FIELD REPORT

Project:	Number:	065
	Date:	11.28.2014
	Temperature:	High 30's
FFKR Proj #:	Weather:	Cloudy and High Wind
Contractor:

Progress: Carpet, plank and sheet vinyl flooring is being installed on 5th and 4th floor of B building. Corner guards, wall base and wall protection bumpers are also going in.

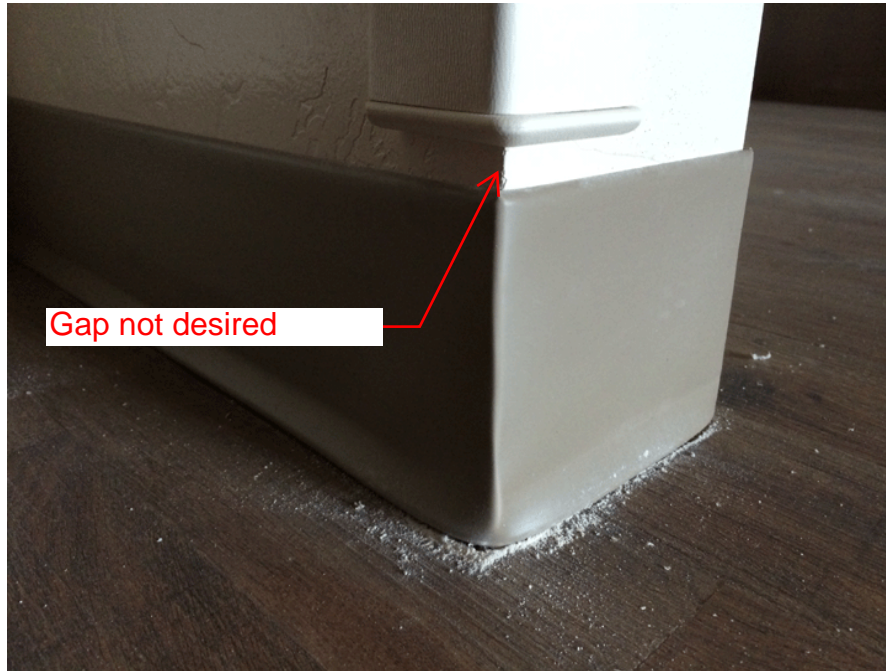
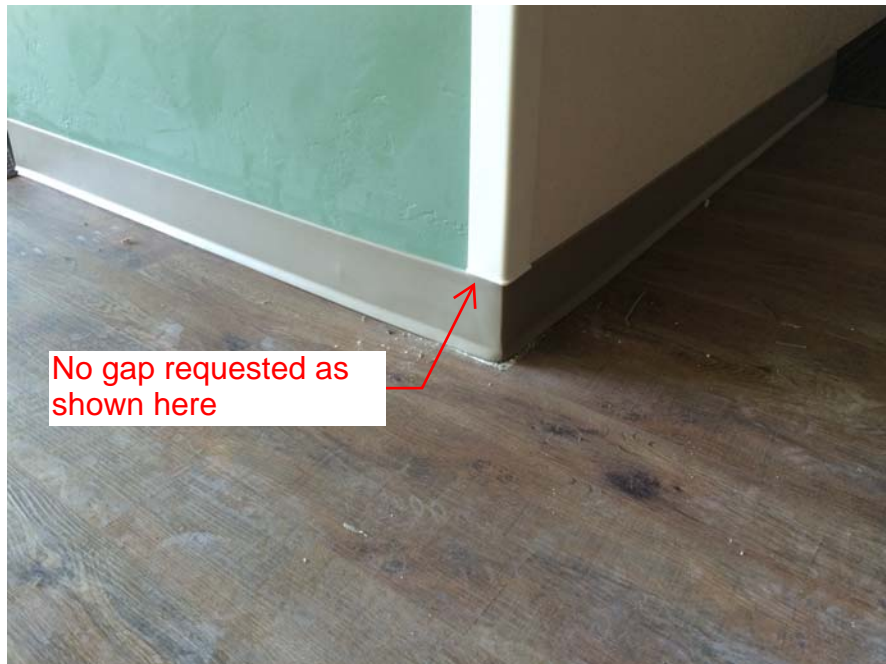
Item 01:

- 141128-01 **Corner guards:** some corner guards are installed flush with the carpet or rubber base, and some are installed so that there is a gap between the two materials. The intent was for these materials to be flush as diagramed and noted in the product's specifications and installation documents. Please install them per manufacturer's recommendations.

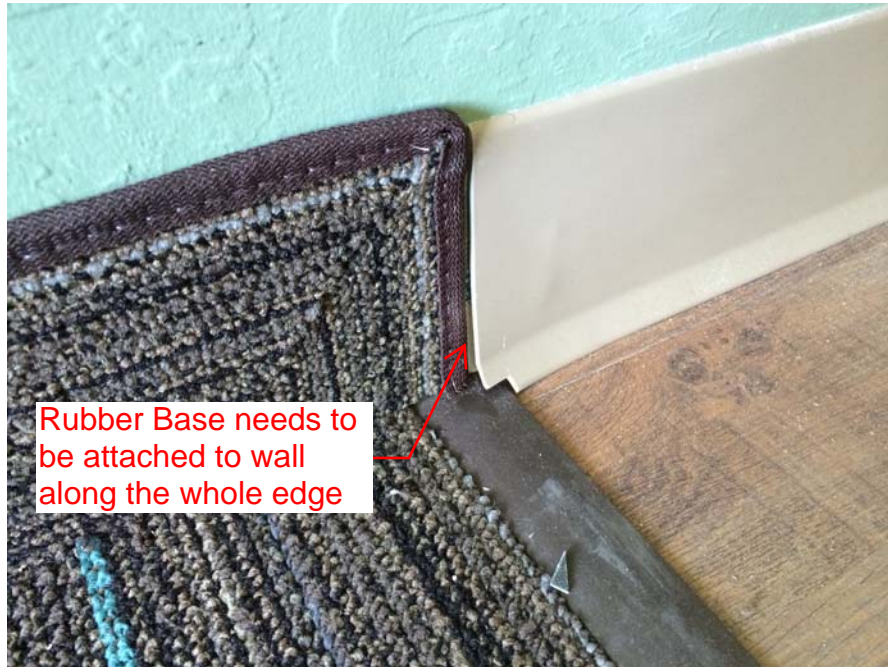
Item 02:

- 141128-02 **Rubber Base Notch:** Notching the rubber base over the thresholds is ok, but you need to make sure that the rubber base is stuck to the wall and won't have opportunity to be peeled off.

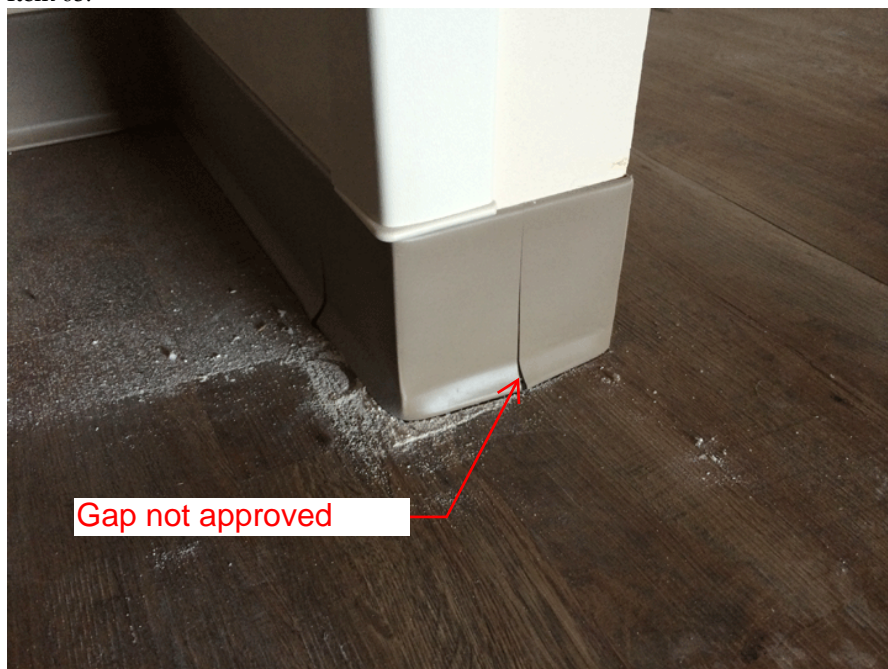
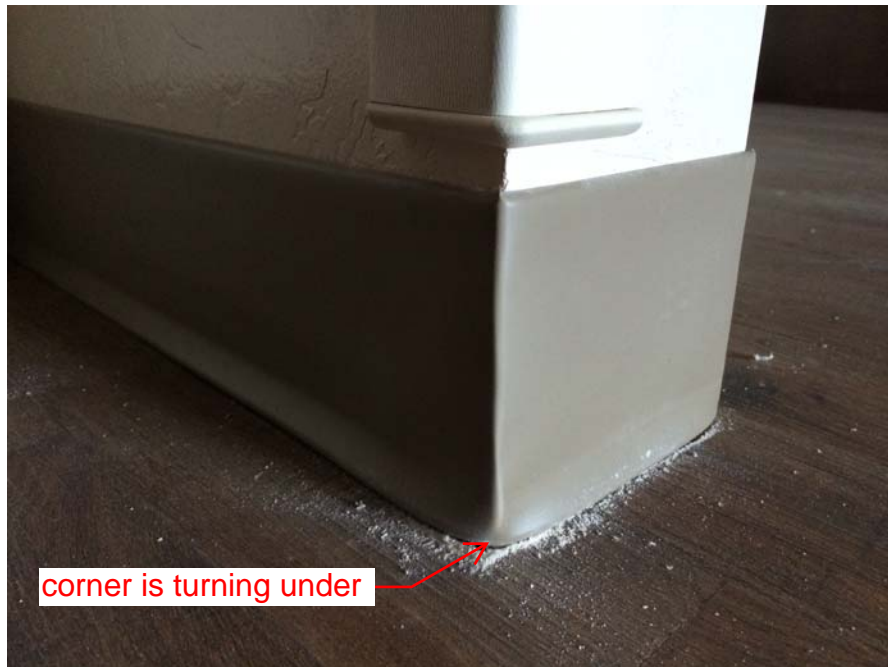
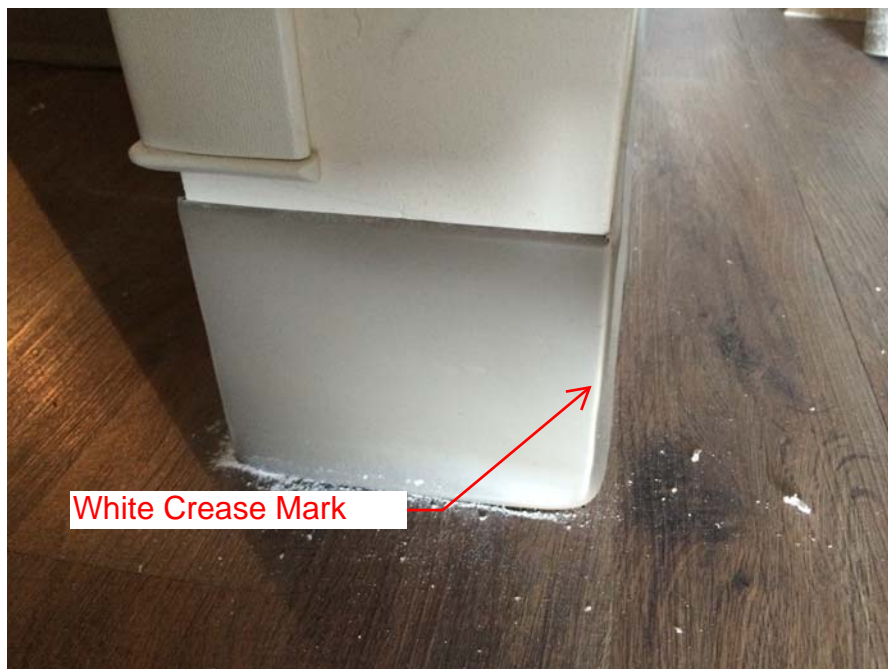
Item 03:

- 141120-03 **Rubber Base – Preformed Corners:** The preformed corners aren't seaming well. They also need to be stuck to the wall better. Some of the spaces have a "site installed base." I assume this is done to as an option for us to review to replace the preformed corners. If we proceed with this option, we need to limit the under turn on the corner's bottom lip, and the white crease mark.

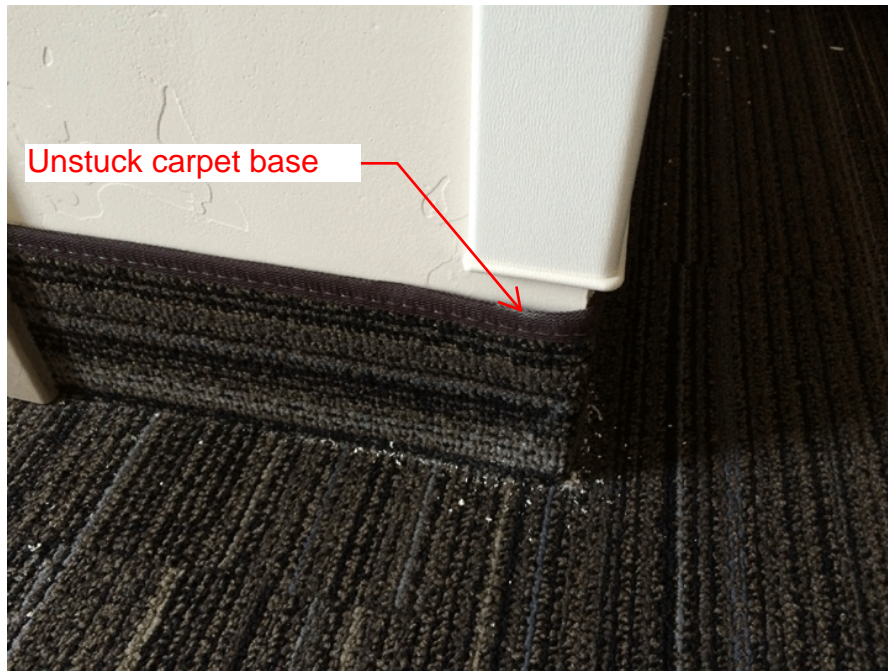
Item 04:

- 141120-04 **Carpet Base:** Please make sure the carpet base is glued to the wall in all places. Gaps like image shown will not be accepted.
- 141120-05 **Sheet Vinyl Flooring:** This is looking really good, and is being installed per our Model room Mock up discussion with cut seam put at the back of the space and allowing a full tile at threshold.

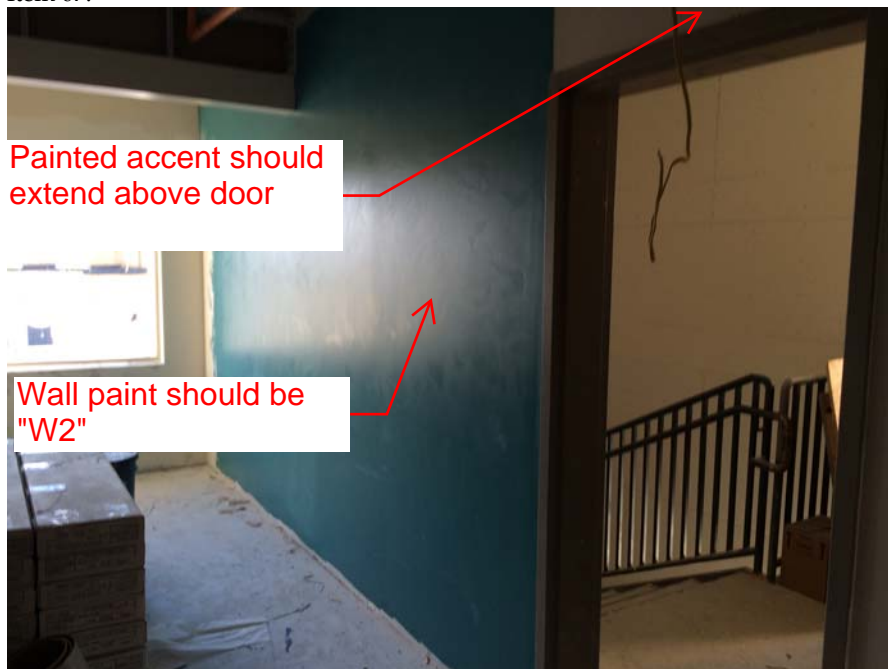
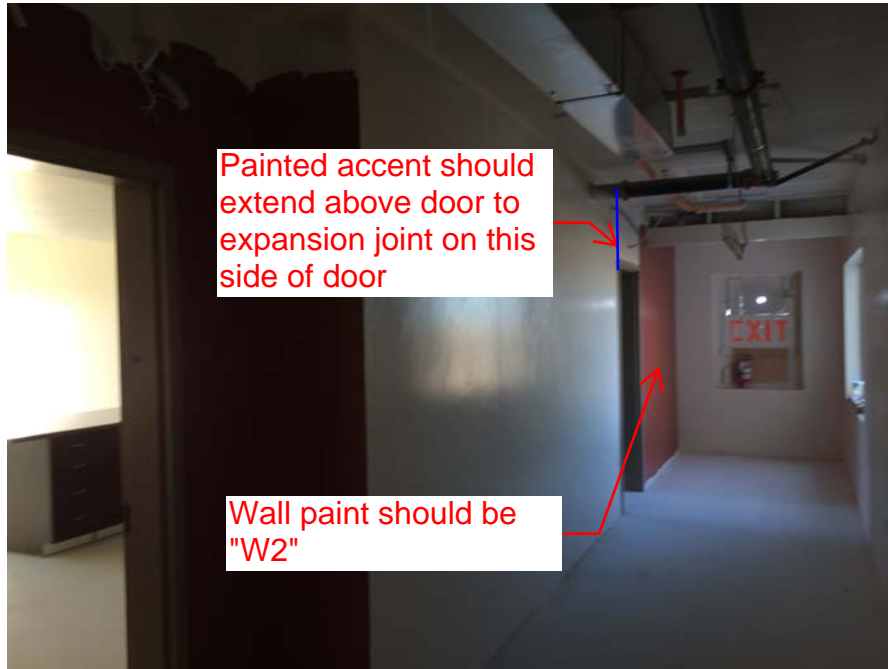
Item 07:

- 141128-06 **Luxury Vinyl Plank:** The LVT flooring in the kitchens is also looking really good and is being installed per direction.
- 141128-07 **Accent Paint:** The accent paint at the end of the Halls is not
-

correct. Currently each floor has the door alcove paint (red, green, teal, yellow) painted in the location that "W2," Sycamore Tan is supposed to be painted. These colored walls only happen at the door alcoves, living room walls and inside the stair landings. See Sheet D1/A-713B for reference. It is also desired to have the accent paint extended above the door to expansion joint.
